## A16.0 Land quality

PROJECT  
New Port Facility at the Falkland Islands

TITLE  
Exploratory Hole and Surface Water Sample Locations

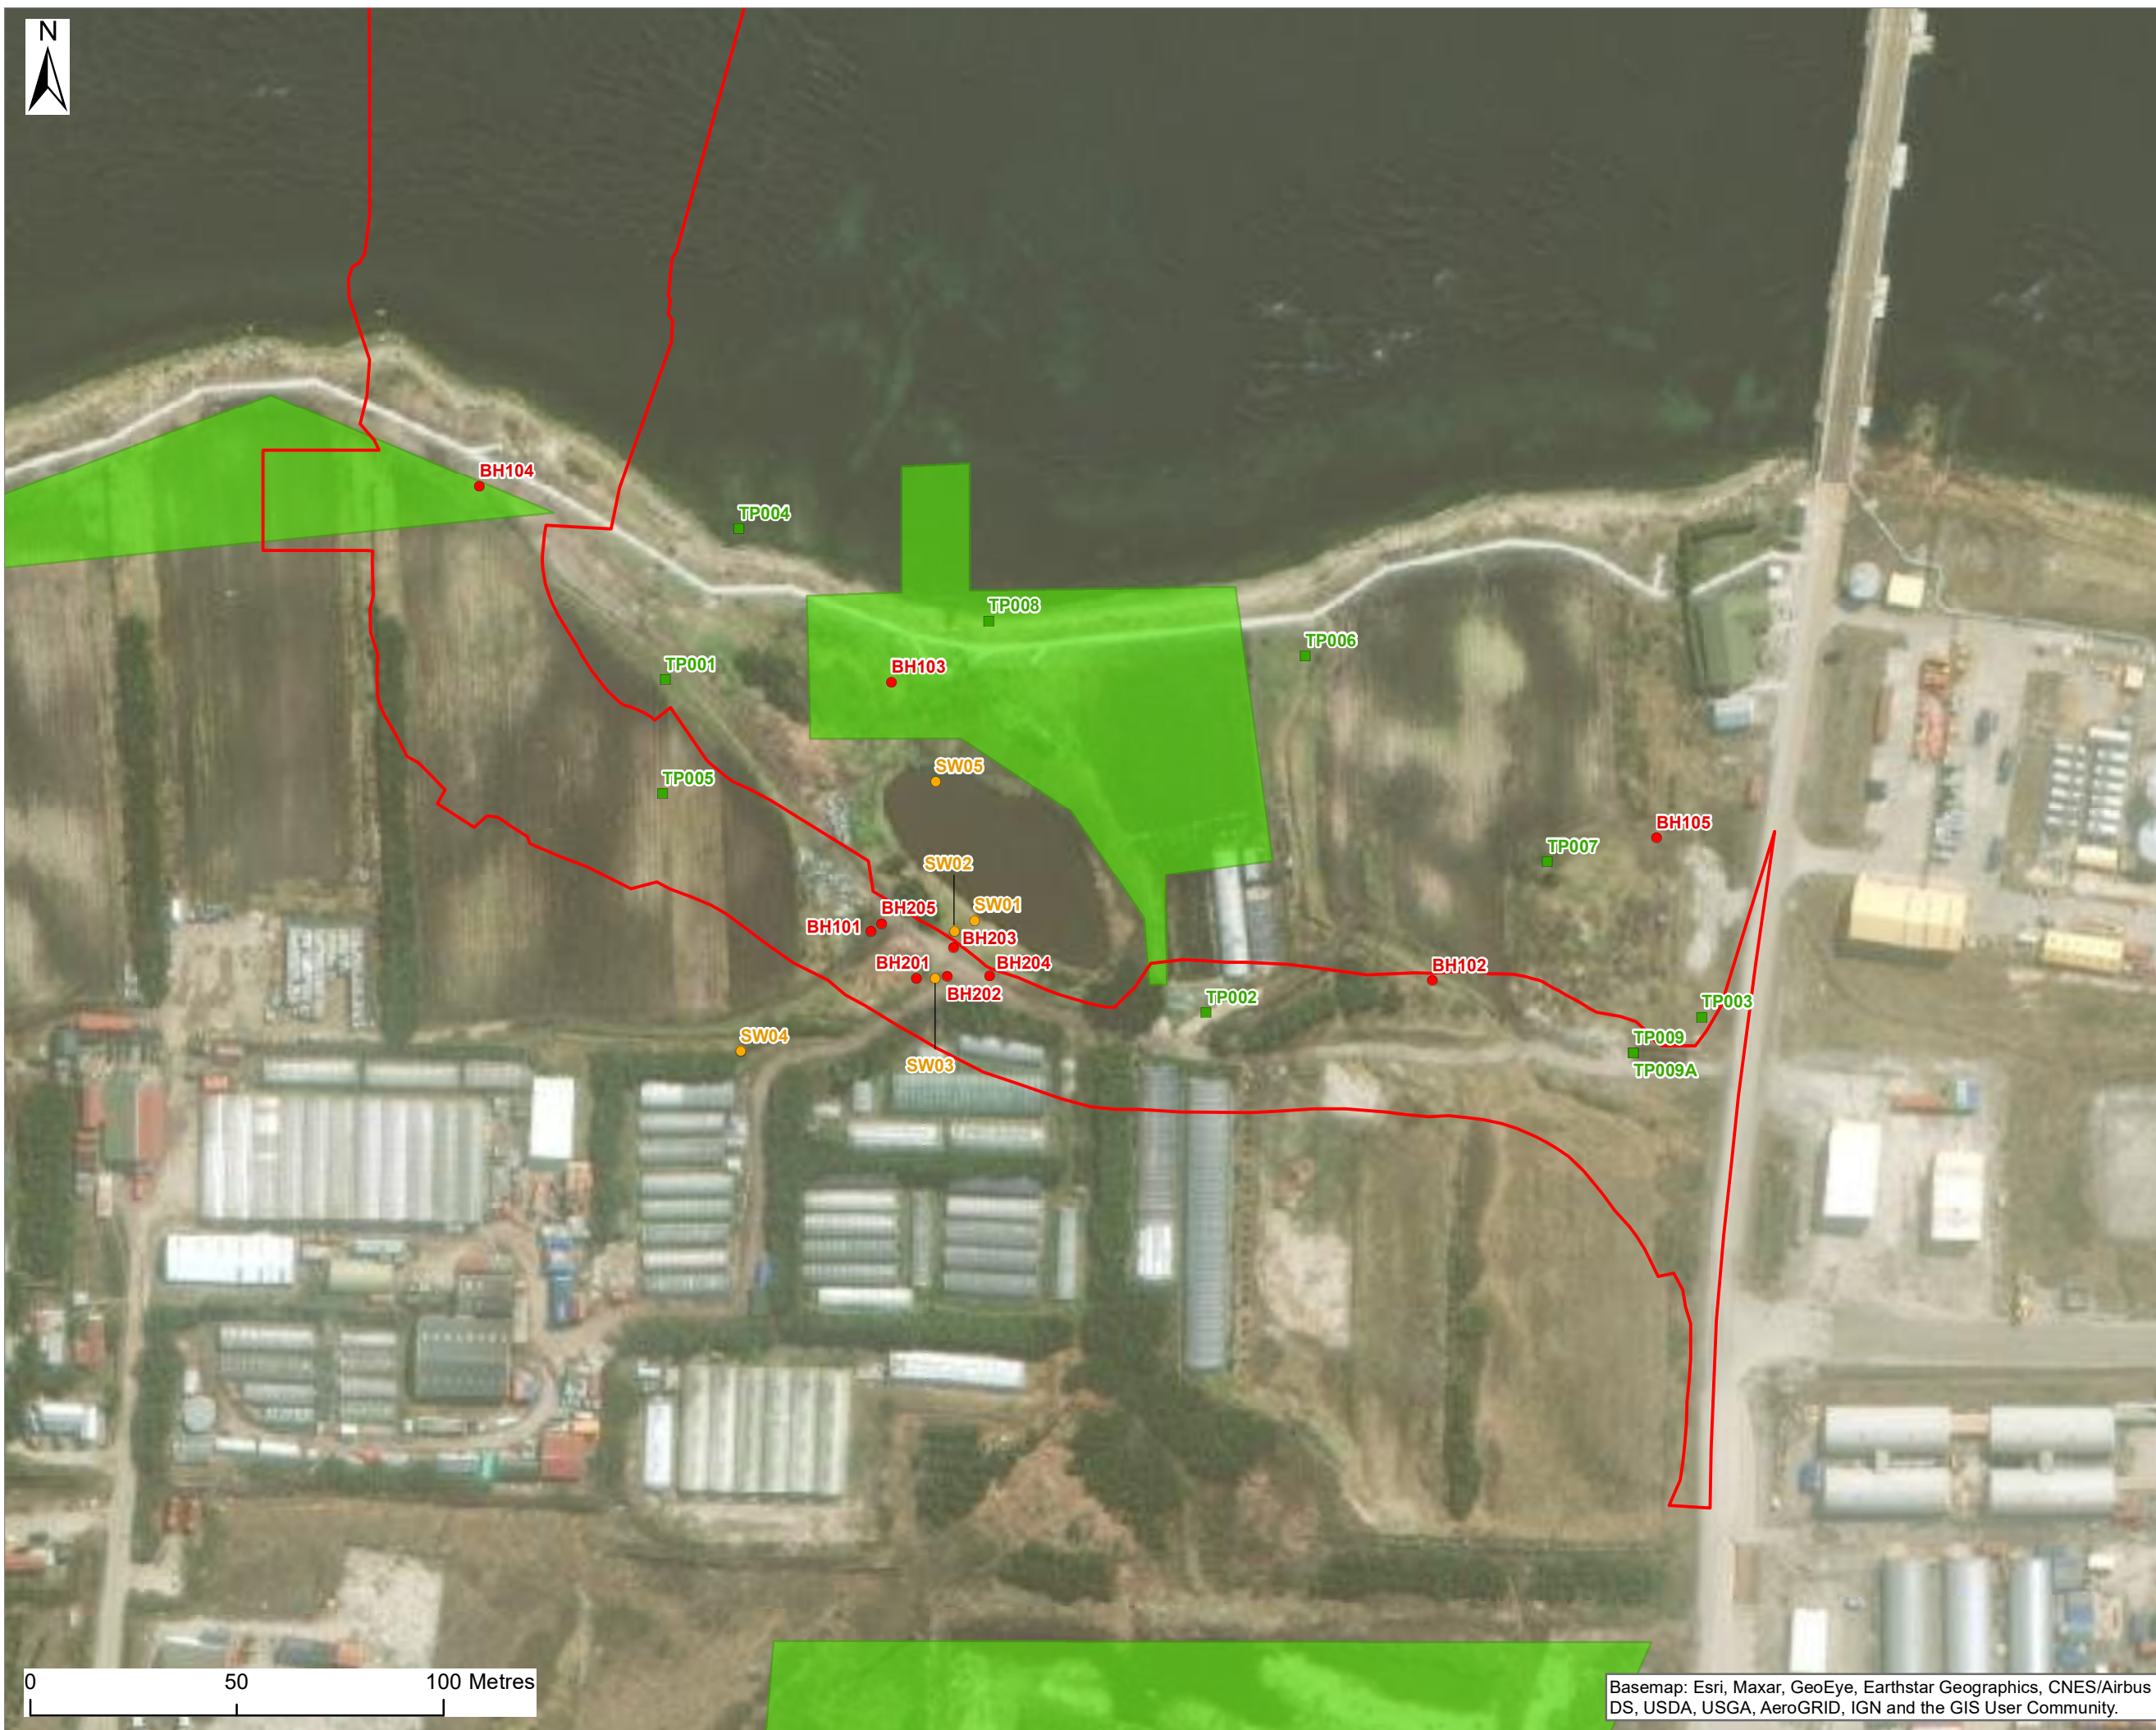
DRAWN	CHECKED	APPROVED
FC	PP	SR
DATE	SCALE	REF.
01.12.21	1:1,500	
FIGURE No.	SUITABILITY	REVISION
16-1	S2	P02

- Key**
- Proposed scheme footprint
  - Construction phase site layout
- Sample Locations**
- Borehole
  - Surface water
  - Trial pit

A ground investigation including sampling was undertaken following completion of a desk-based review of existing data sources which targeted two areas of potential concern within the study area, namely an area of the proposed access road and the FIPASS tanks. In addition to the targeted investigation into these specific areas, a ground investigation was undertaken for geotechnical purposes and the information from this investigation has also been used to inform the baseline understanding of the area. The site-specific investigation works undertaken are summarised below with the exploratory hole locations illustrated on **Figure 16.1**.

To further investigate this area, a specific land quality ground investigation was undertaken. As shown on **Figure 16.1**, the investigation comprised the excavation of five boreholes to a maximum depth of 9.3m bgl and the collection of soil, soil leachate and groundwater samples for laboratory analysis. In addition, surface water samples were collected and tested from the drainage ditch and irrigation pond (**Figure 16.1**). Groundwater level monitoring was also undertaken.

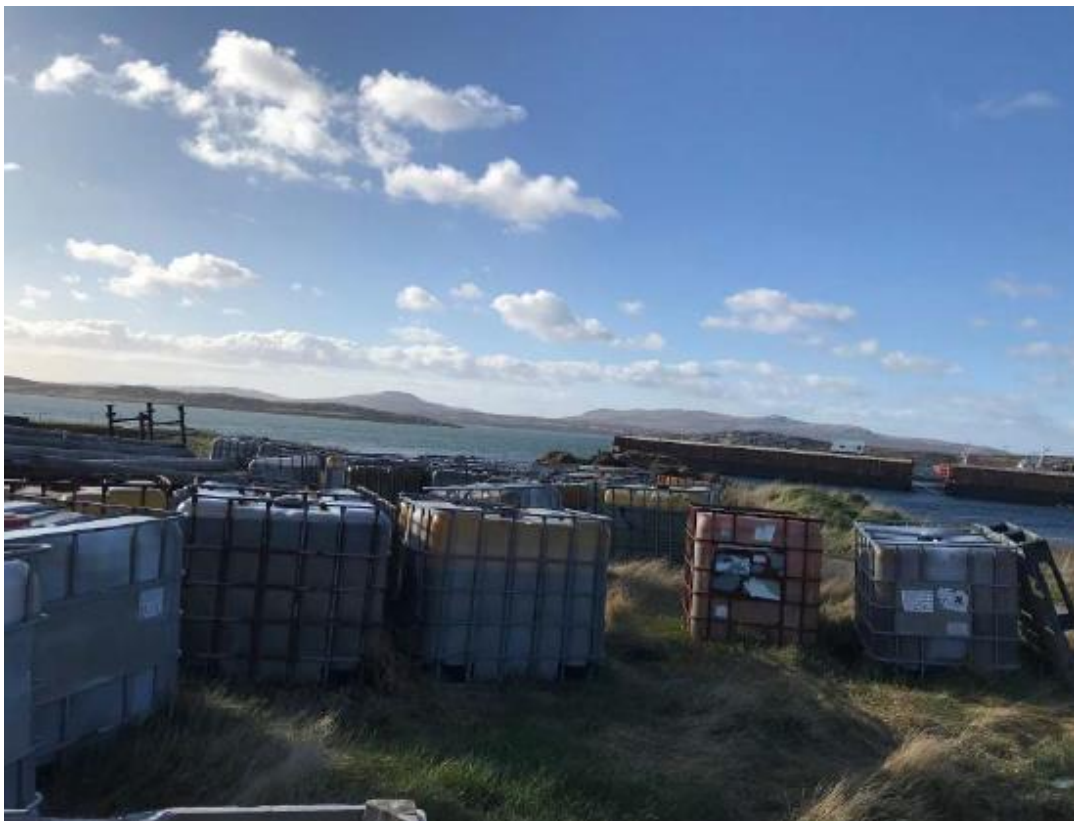
**Plate 16.1** IBC's containing diesel

During the October 2020 geotechnical site investigation (**Ref. 12**), it was noted that waste materials (wood and organic material), scrap metal, parts of machinery and IBCs containing waste diesel were located in the vicinity of the proposed new access road (**Plate 16.1**), near to the irrigation pond. In addition, during a site walkover, an oily sheen was observed on a drainage ditch which runs through the area of the proposed access road and on the surface of the water within the irrigation pond (see **Figure 16.2** for location of drainage ditch and irrigation pond and **Plate 16.2** for image). Evidence of the use of an oil spill response kit within the drainage ditch and irrigation pond was also observed (**Plate 16.3**). Anecdotal evidence from F.I.G.'s Environmental Officer and Policy Advisor indicated there was a historical spillage of diesel from a pump used to remove water from the irrigation pond.

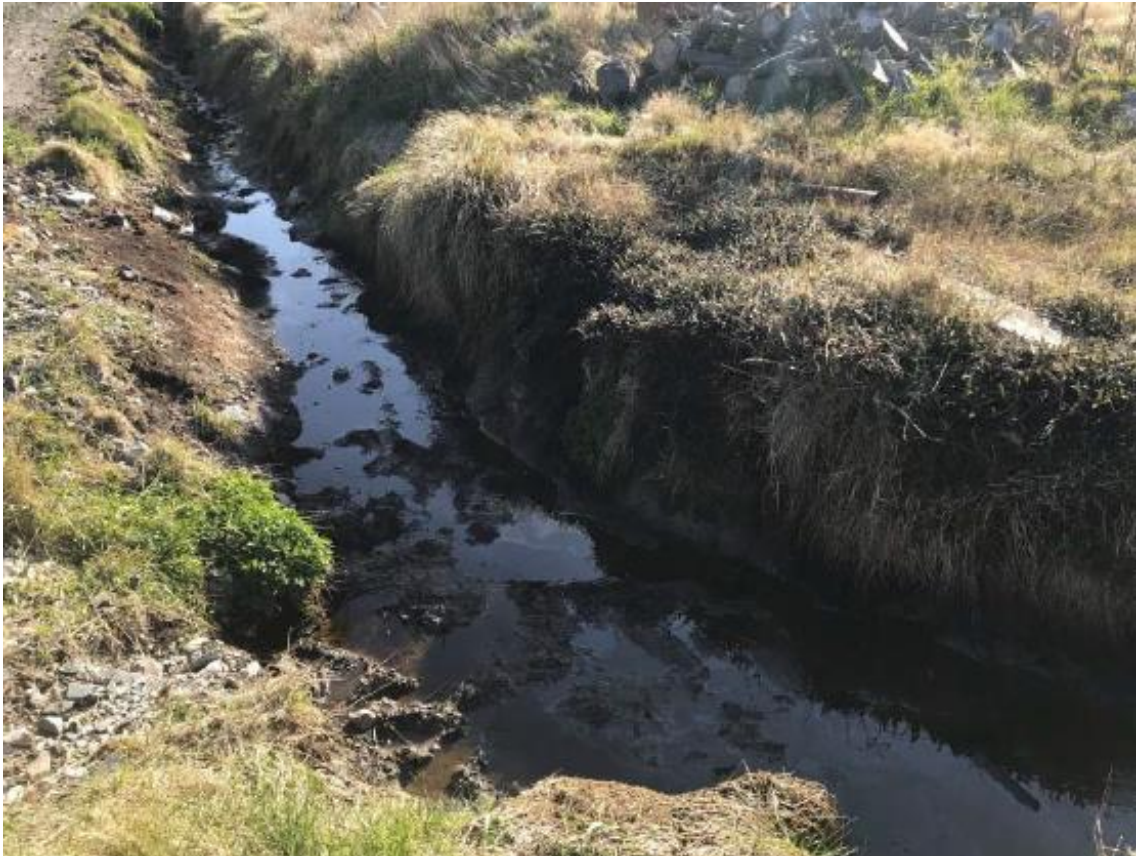
**Plate 16.2** Oily sheen on surface of ditch which feeds the irrigation pond

The elevated PAHs and TPH above EQS recorded in groundwater samples and surface water samples generally correspond to the location where an oily sheen associated with the diesel spillage was observed on the drainage ditch and in groundwater in the area immediately surrounding the ditch. A surface water sample collected from the irrigation pond did not record TPH above EQS. As reported in **Section A16.1.1.1**, the lack of appropriate sample containers in the Falkland Islands and the long transport time to the laboratory in the UK may have resulted in the degradation of volatile contaminants before the samples arrived in the UK. In addition to the logistical constraints, a number of the glass bottles used to collect water samples had cracked during the freezing process required for transport meaning some samples were lost completely. Seven other water samples had insufficient sample for the full suite of analysis, therefore uncertainty in the data meant that a potential risk to the pond could not be entirely discounted.

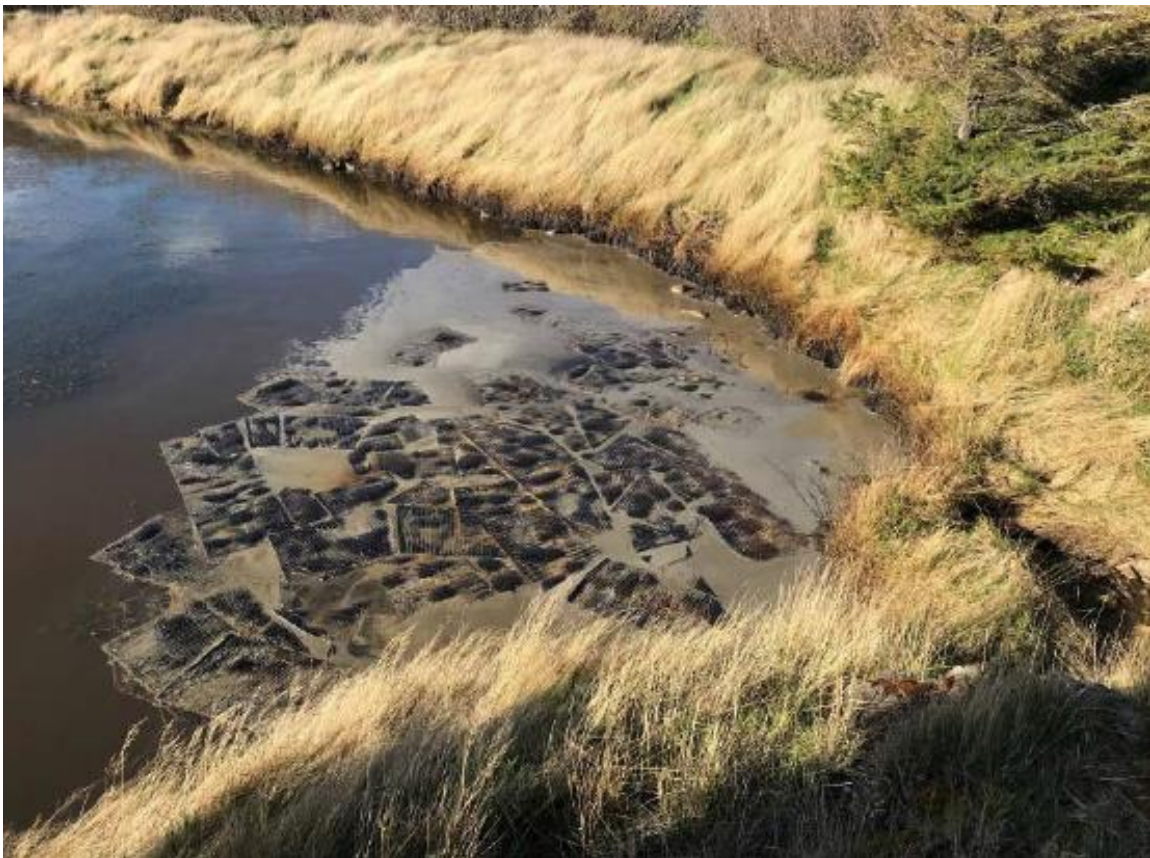
**Plate 16.3** Hydrocarbon sheen on surface of the irrigation pond with spill mats also evident

A historical fuel spillage within a drainage ditch connecting to the irrigation pond is considered to be the main area of concern in relation to potential hazard to human health. Elevated TPH concentrations above the benzene EQS were identified within soil leachate, groundwater samples and surface water samples. Contaminated groundwater associated with the historical spill could potentially pose a risk to construction workers, if encountered during excavation works. There is also the potential for neighbouring site users to be impacted through the accidental discharge of the contaminated surface water within the ditch into the pond which is utilised by Stanley Growers Ltd for the purpose of irrigation. Although contamination has been identified within the irrigation pond, further release of water from the drainage ditch could result in the water being unsuitable for use as an irrigation source. Irrigation of crops with contaminated water, and subsequent consumption of the produce, could potentially pose an unacceptable hazard to human health. It should be noted that the presence of hydrocarbons in the pond is known to Stanley Growers Ltd.
